Manhole Inspection Summary

Manhole # S45C__047MH

Insp Date: **8/15/08 9:45 AM**

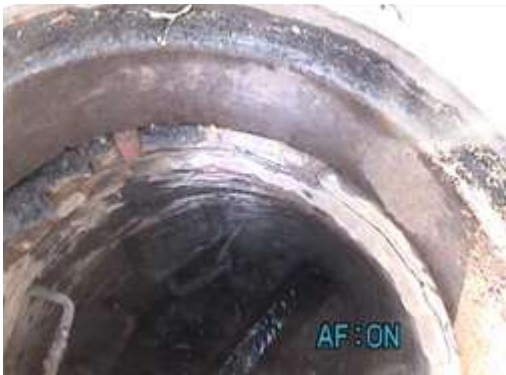
Defect 2

Infiltration: ☐ None ☐ Joint ☐ Cracks ☐ Mortar ☐ Roots ☒ **Wall**

Infiltration

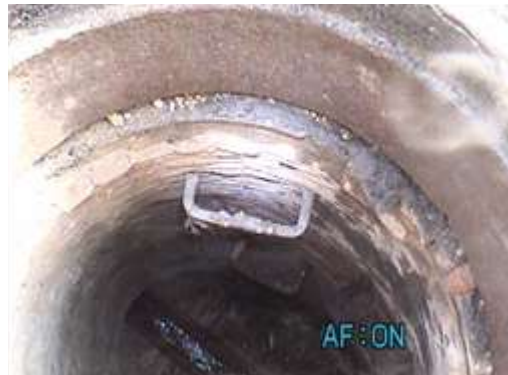
Defect 1

Frame Offset: **1** (in.) Condition: ☐ Sound ☐ Cracked ☒ **Leaks**

Frame leaks

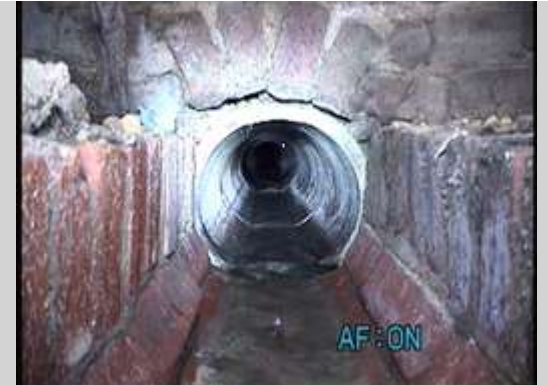
12 O'Clock Outflow

8 in. Circular Gravity Sewer
Pipe Out @ 12 O'Clock

Pipe Height: **8.4** (in.) Rod and Bar (Angled)
Pipe Material: **Clay** ☐ Pipe Lined
Invert Depth: **8.85** (ft.) Flow Characteristics: **Fast**
Deposits: ☒ None ☐ Mud ☐ Sludge ☐ Debris ☐ Grease
Silt Depth: (in.) Deposits Extent:
Infiltration: **None** Pipe Seal Cond: **Sound**

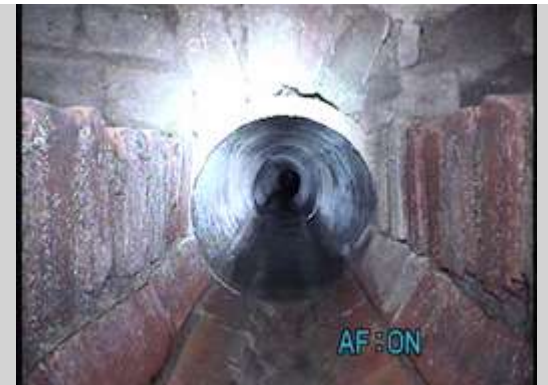
6 O'Clock Inflow

8 in. Circular Gravity Sewer
Pipe In @ 6 O'Clock

Pipe Height: **8.4** (in.) Rod and Bar (Angled)
Pipe Material: **Clay** ☐ Pipe Lined
Invert Depth: **8.75** (ft.) Flow Characteristics: **Fast**
Deposits: ☒ None ☐ Mud ☐ Sludge ☐ Debris ☐ Grease
Silt Depth: (in.) Deposits Extent:
Infiltration: **None** Pipe Seal Cond: **Sound**
